Safety Notice – powerCON TRUE 1

Date: 4th July 2018
Author: Thomas Walker
Product: Tessera XD

Neutrik have issued a safety notice for the powerCON TRUE 1 connector system, used as the power connection on the Tessera XD product.

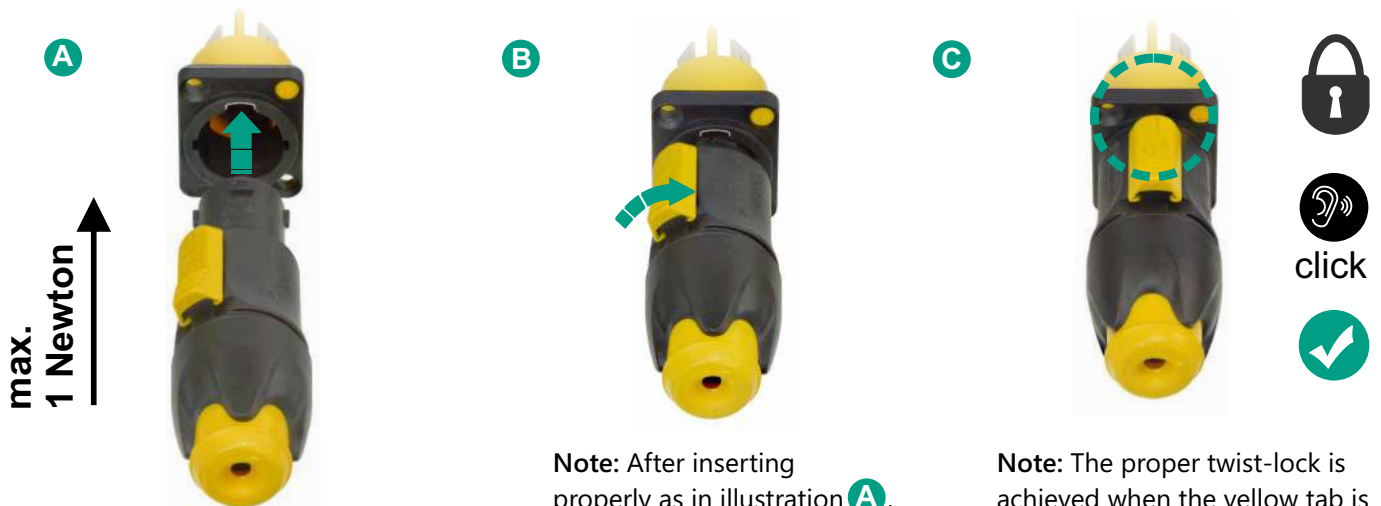
Through improper use and the excessive use of force, the encoding lugs and guide slots in the connector system can become so severely worn or damaged that it is possible to insert the cable connector the wrong way. However, when inserted the wrong way, the cable connector should not twist-lock into place.

A cable connector inserted the wrong way could, in some circumstances, lead to contact between live wires and the grounding contact in the plug socket.

Note: When connecting, match the notch on the cable connector to the corresponding guide slot on the chassis.

Note: After inserting properly as in illustration **A**, twist the cable connector clockwise to lock.

Note: The proper twist-lock is achieved when the yellow tab is in the position shown in **C** and an audible «click» is heard.

To determine that the cable connector is inserted correctly, follow the use instructions and listen for the "click" when performing the twist-lock. Immediately unplug any connector that does not twist-lock correctly in place.

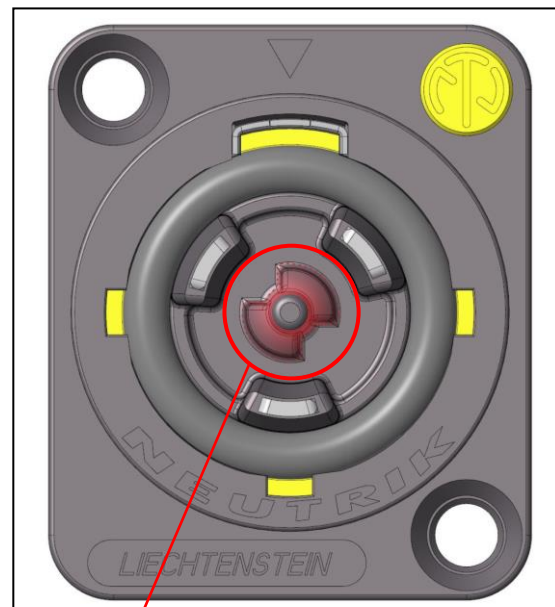
Modification on appliance inlet NAC3MPX:

Enlargement of center stopper
