## Safety Notice – powerCON TRUE 1

Date: 4<sup>th</sup> July 2018  
Author: Thomas Walker  
Product: Tessera XD

# SAFETY NOTICE

# powerCON TRUE1

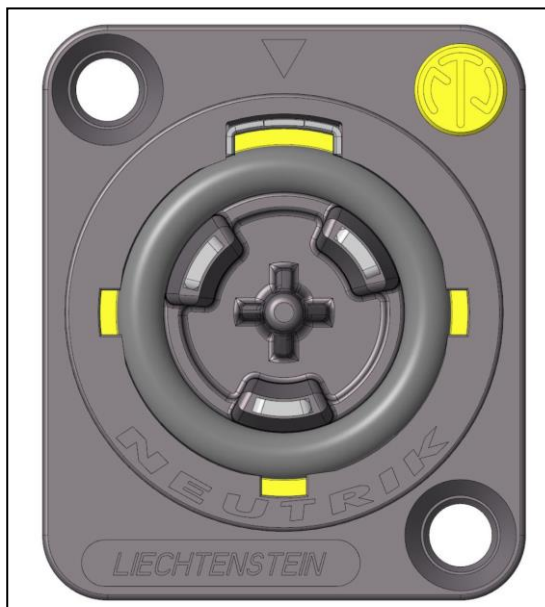
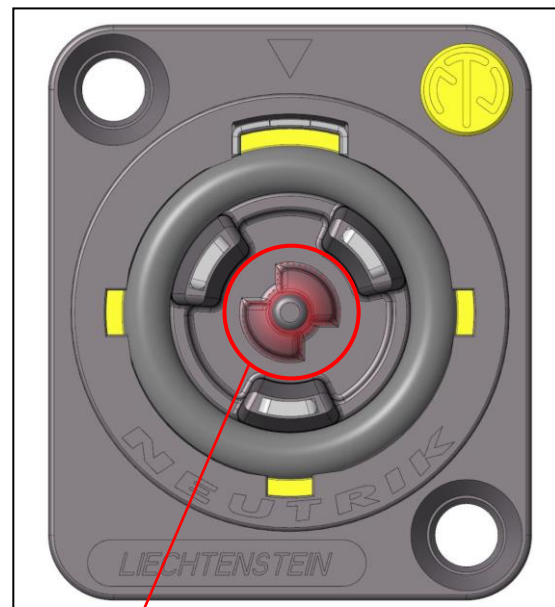
Modification on appliance inlet NAC3MPX:

Enlargement of center stopper

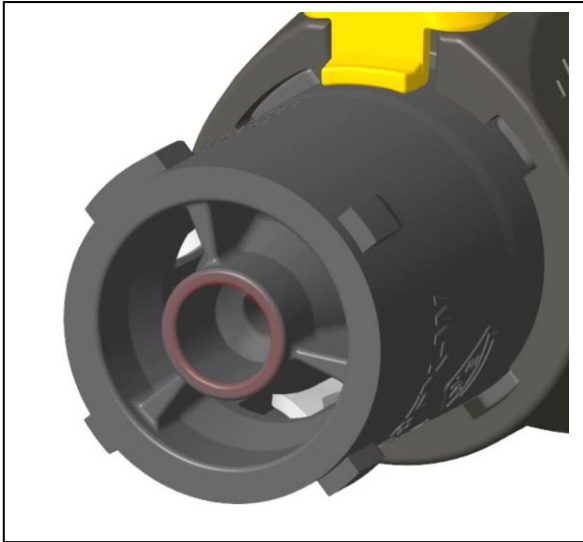
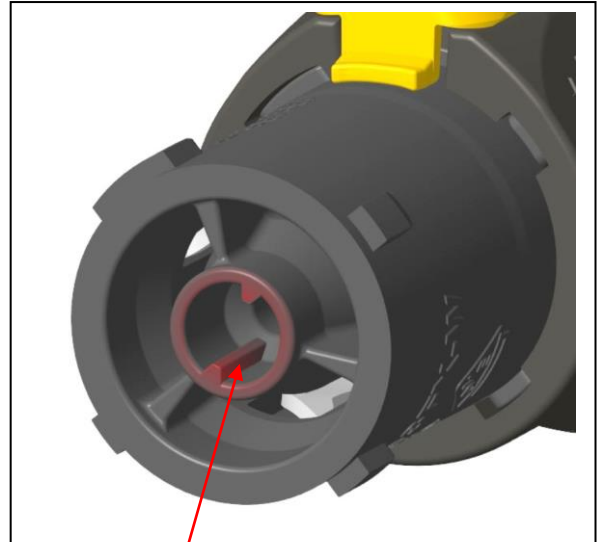
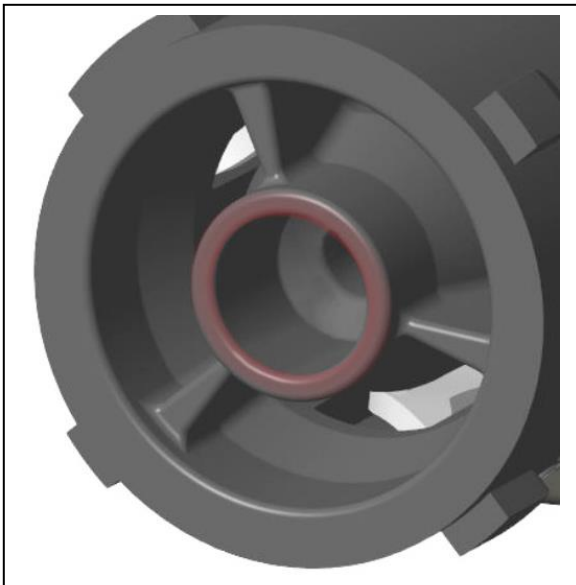
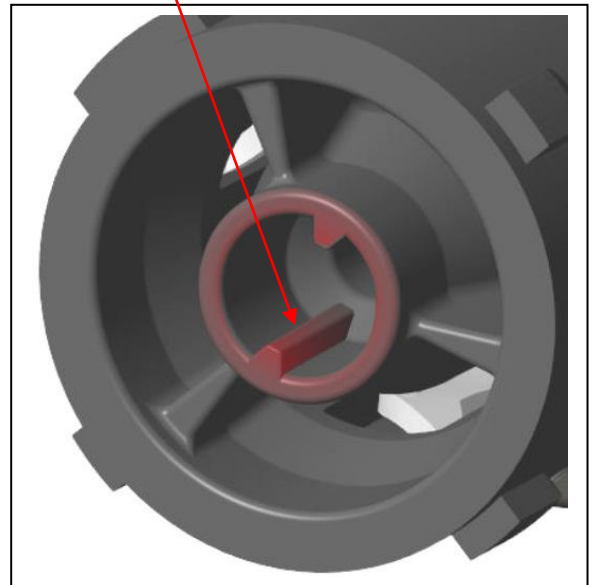
Modification on cable connector NAC3FX-W:

additional ribs

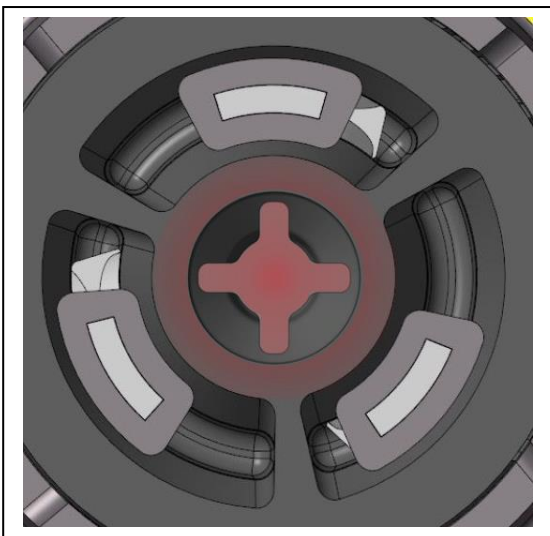
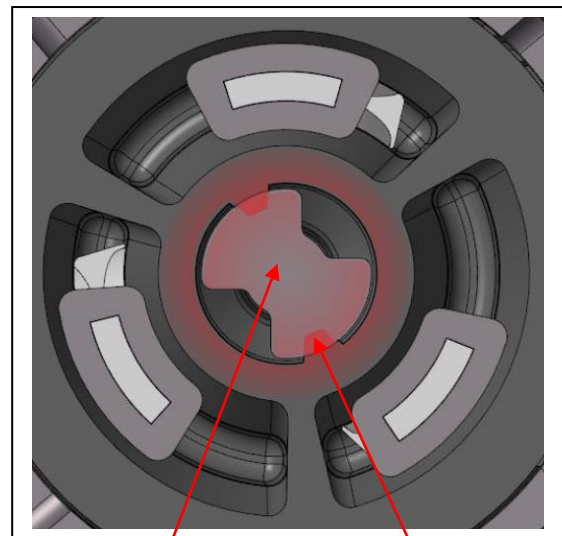
Wrong insertion by 90°:

center stopper does block insertion by the ribs

In the case of wrong insertion the additional ribs run up the stopper and prevent full insertion thus contacting is avoided.

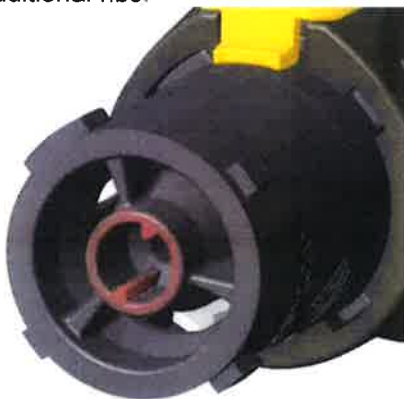
Additional ribs:

To exclude the risk of contacting live and earth when wrongly inserting a connector improvements have been made.
