Safety Notice – powerCON TRUE 1

Date: 4th July 2018
Author: Thomas Walker
Product: Tessera XD

Neutrik have issued a safety notice for the powerCON TRUE 1 connector system, used as the power connection on the Tessera XD product.

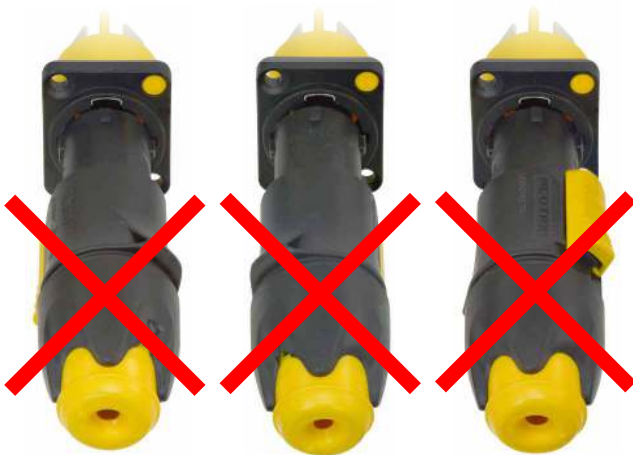
Through improper use and the excessive use of force, the encoding lugs and guide slots in the connector system can become so severely worn or damaged that it is possible to insert the cable connector the wrong way. However, when inserted the wrong way, the cable connector should not twist-lock into place.

Note: After inserting properly as in illustration **A**, twist the cable connector clockwise to lock.

Note: The proper twist-lock is achieved when the yellow tab is in the position shown in **C** and an audible «click» is heard.

incorrect insertion may cause electrical contact misalignment resulting in equipment malfunction and/or personal injury.

Please regularly check the condition of your powerCON TRUE1 connector system (cable connector & chassis) for clear signs of wear and tear.

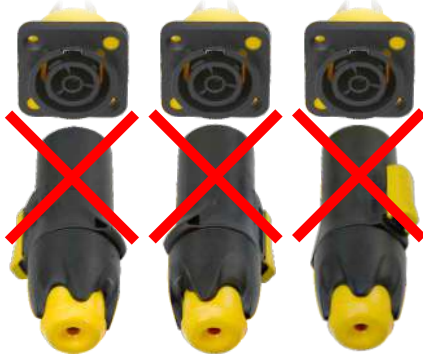
Note: When connecting, match the notch on the cable connector to the corresponding guide slot on the chassis.

Note: After inserting properly as in illustration A, twist the cable connector clockwise to lock.

Note: The proper twist-lock is achieved when the yellow tab is in the position shown in C and an audible «click» is heard.

incorrect insertion may cause electrical contact misalignment resulting in equipment malfunction and/or personal injury.

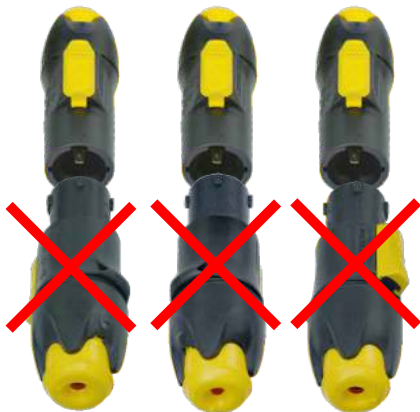
Note: When connecting, match the notch on the cable connector to the corresponding guide slot on the chassis.

Note: After inserting properly as in illustration A, twist the cable connector clockwise to lock.

Note: The proper twist-lock is achieved when the yellow tab is in the position shown in C and an audible «click» is heard.

incorrect insertion may cause electrical contact misalignment resulting in equipment malfunction and/or personal injury.
