## Safety Notice – powerCON TRUE 1

Date: 4<sup>th</sup> July 2018  
Author: Thomas Walker  
Product: Tessera XD

# SAFETY NOTICE

# powerCON TRUE1

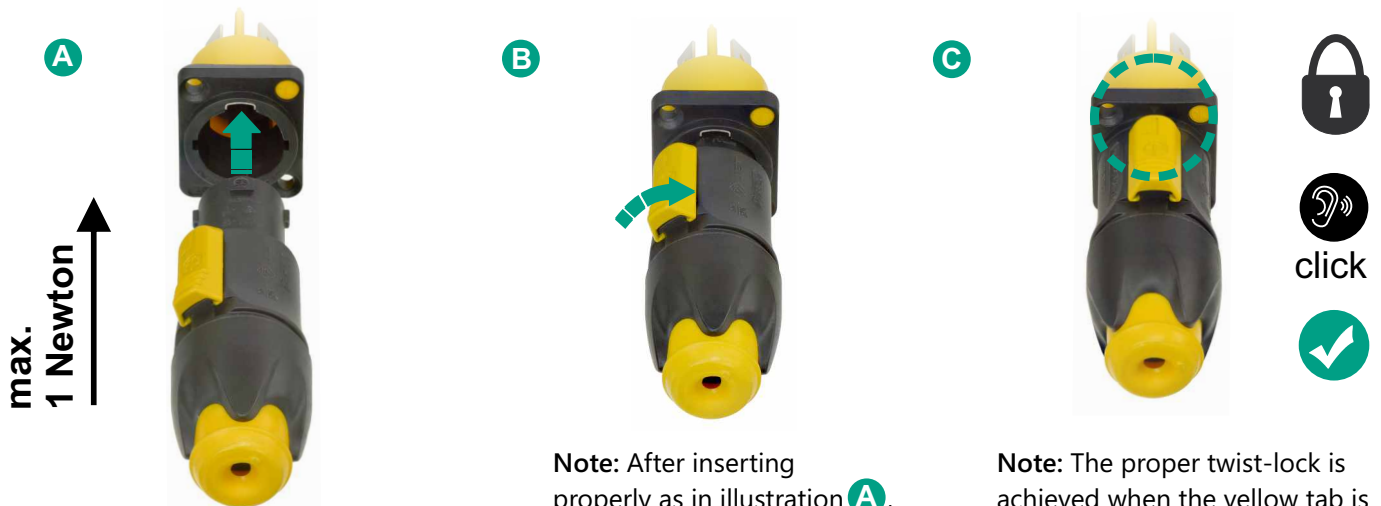
Through improper use and the excessive use of force, the encoding lugs and guide slots in the connector system can become so severely worn or damaged that it is possible to insert the cable connector the wrong way. However, when inserted the wrong way, the cable connector should not twist-lock into place.

A cable connector inserted the wrong way could, in some circumstances, lead to contact between live wires and the grounding contact in the plug socket.

**Note:** When connecting, match the notch on the cable connector to the corresponding guide slot on the chassis.

**Note:** After inserting properly as in illustration **A**, twist the cable connector clockwise to lock.

**Note:** The proper twist-lock is achieved when the yellow tab is in the position shown in **C** and an audible «click» is heard.

To determine that the cable connector is inserted correctly, follow the use instructions and listen for the "click" when performing the twist-lock. Immediately unplug any connector that does not twist-lock correctly in place.

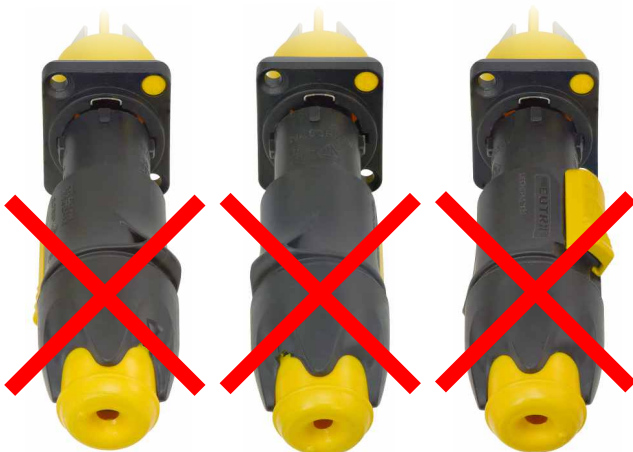
**SAFETY WARNING**

incorrect insertion may cause electrical contact misalignment resulting in equipment malfunction and/or personal injury.

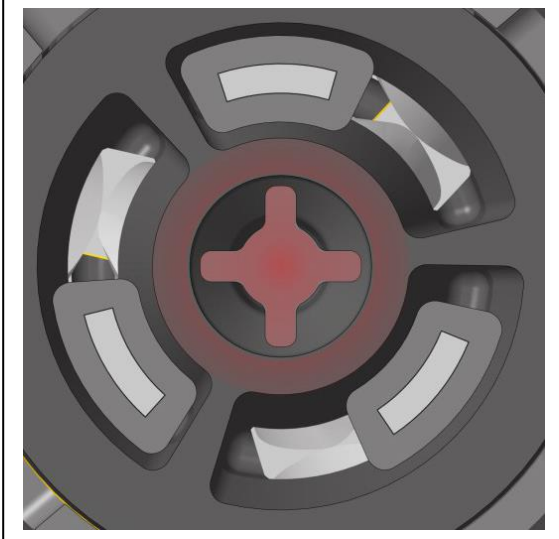
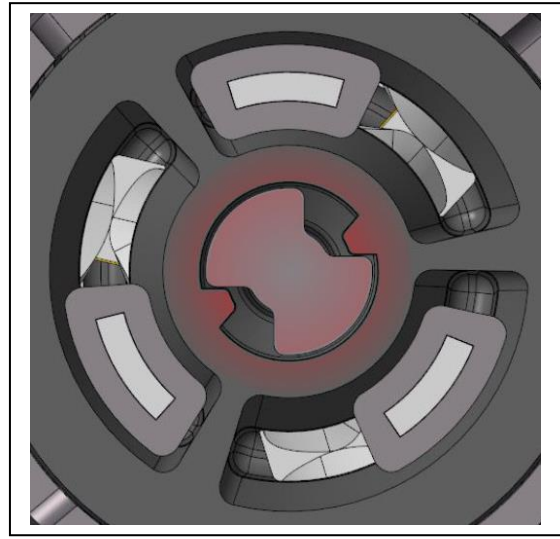
Correct insertion:

Wrong insertion 90° clockwise or 180° twisted does not cause any wrong contacting. We also are expecting a statement of non-objection from VDE.

Modification on appliance inlet NAC3MPX:
